**RFP – Request for Proposal
for a Feasibility Study on Adaptive Re-Use**

**Requested by
Windham Preservation Inc.
Nine Weir Court
Windham, CT 06280**

Structural Condition Assessment Report
Windham Inn
4 Scotland Road
Windham, CT 06280

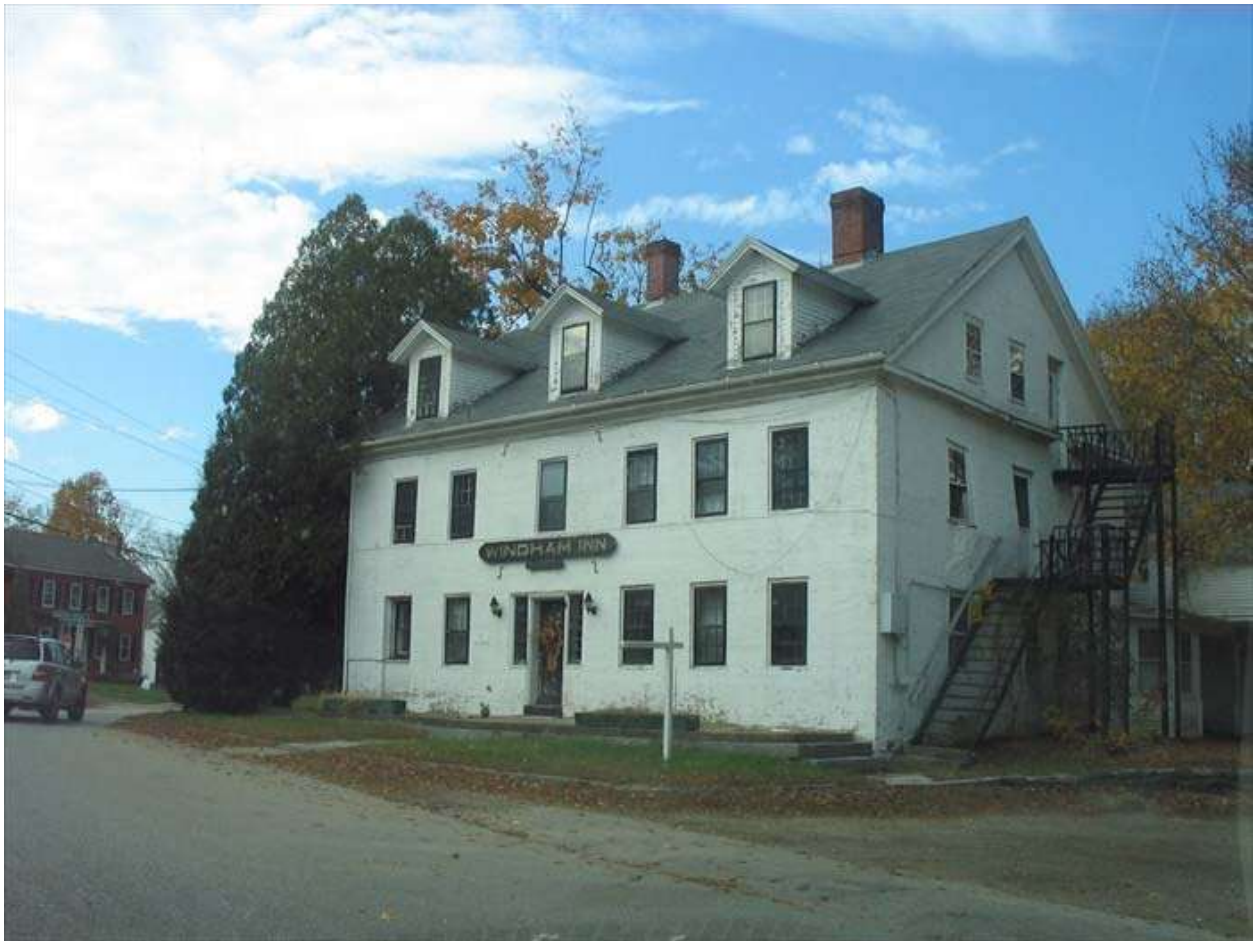
In general, the building is in poor condition, and currently presents a safety hazard based on potential collapse. Both the original building and the additions are damaged. Major conditions include the ongoing failure of the brick wall of the east face of the original structure, the failure of the lateral restraint of the roof rafters in the addition near the entry to Unit #5, failure of the exterior stair connections to the building, failure of the stringer connection of the interior basement stairway, ongoing collapse of the interior ceiling finish, multiple roof leaks, and decayed beams. The damaged finishes and floor surface need to be repaired. The mechanical/electrical systems need to be replaced. The presence of hazardous mold, lead paint, and asbestos finishes need to be verified & mitigated. Our office should be notified of any damage to structure observed during renovation not currently described in this report.

Figure 1: Windham Inn, South Face Looking North

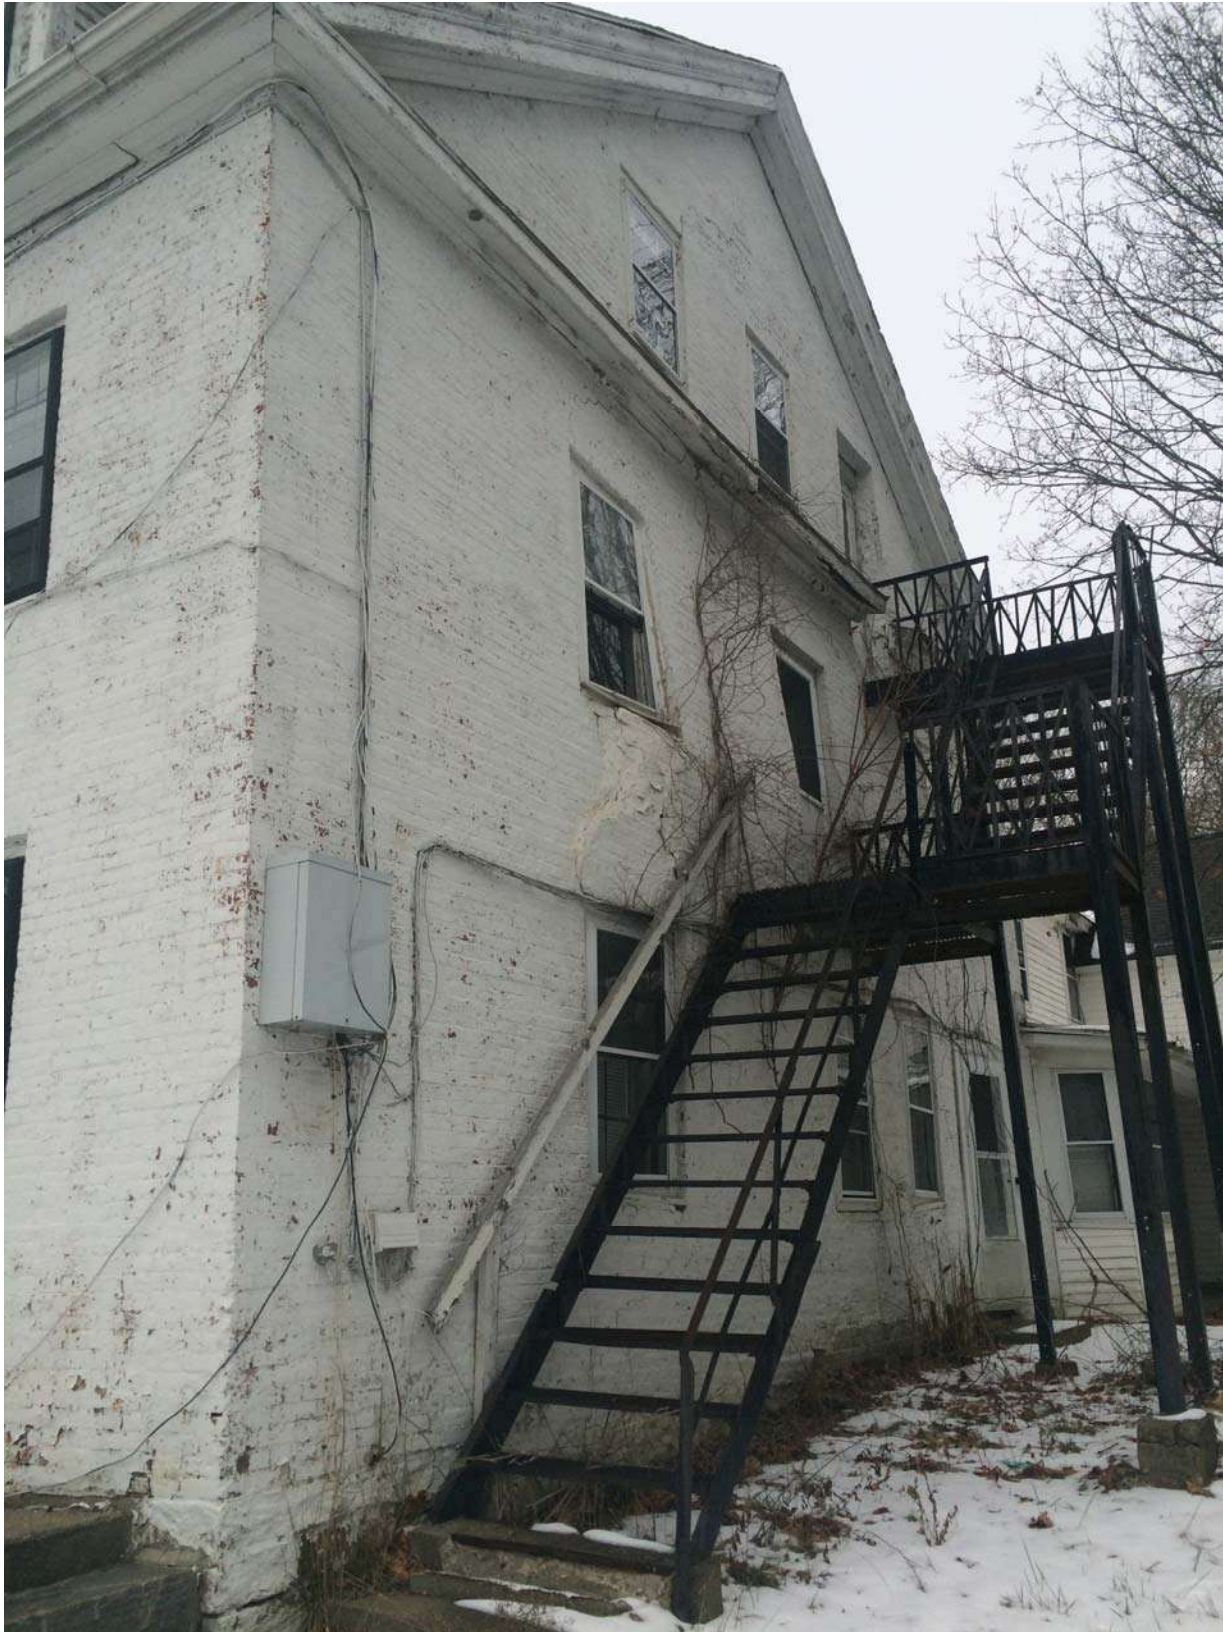
The original building appears to have been a brick masonry structure, bearing on what appears to be a stone masonry foundation. There is a mixture of brickwork and concrete work in areas of the original stone masonry foundation; this seems to be new work installed to correct various defects. One noteworthy area of repair is a poured concrete patch/reinforcement of the foundation along the east wall below the area of deformation in the exterior brickwork. This patch seems to be either in a previously existing, full-height square opening, or in an area cut square for the patchwork. The brick is hard fired, with no evidence of soft brick. The exterior walls of the building appear to be in good condition with the exception of the east wall. The east wall has undergone substantial deformation both in the plane of the wall and out of plane, as can be seen in Figure 5. The east wall is considered failed due to the fact that brick which should be load bearing has cracked and/or fallen from the wall.

Figure 5: Failed East Wall

The east exterior wall of the original building has undergone substantial deformation both in the plane of the wall and out of plane. It is recommended that the floors and the adjacent exterior fire escape be shored from the basement to the roof and that the wall be completely reconstructed either in kind or with an equivalent construction. A smooth and level top of foundation should be created with grout prior to commencing masonry installation. Once the brick masonry wall is reconstructed, the connection of the stair and the bearing ends of the joists must be assured prior to phased removal of shoring.

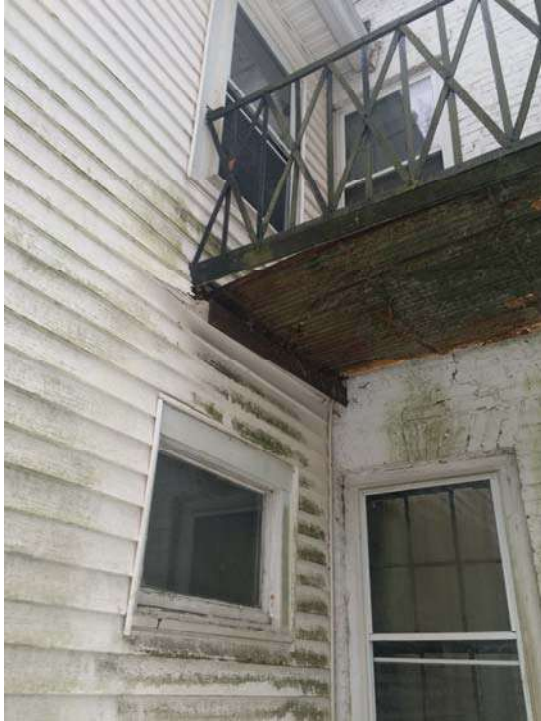
The fire escape on the west face is attached to the addition, where it serves Unit #3 via window egress. The escape is comprised of steel stringers & beams supporting steel bar-grating. The stringers & beams are channels, and are in good condition. The bar-grating is in good condition. The escape is supported by steel angle columns and by connection to the stud framed exterior walls of the addition. The columns are in good condition, with the exception of the fact that one column is an L3x2 steel angle, which cannot span the unbraced length at which it is installed without buckling under load. There are two areas of connection to the stud walls: a bearing ledger for the bar grating on the east side of the upper landing and a series of channel mount connections along the landing's south side. The channel mounts appeared sound at the time of the review, but close observation was prohibited due to safety concerns; the ledger has failed, as was visually apparent due to downward displacement of the bearing end of the bar grating, and the gross deformation of the area of the connection. The failed ledger connection can be seen in Figure 6. Although much of the failed connection is concealed by collapsing finishes, there was visible evidence of decay, indicating that the connection at this location may have failed due, at least in part, to water infiltration at the ledger.

Figure 6: West Face Escape - Failed Connection

The fire escape on the west face is supported by steel angle columns and by connection to the stud framed exterior walls of the addition. The northwest column is an L3x2 steel angle, which cannot span the unbraced length at which it is installed without buckling under load. The ledger must be stripped of finishes and reframed. It should be anticipated that there will be extensive water damage/decay revealed when the finishes are drawn back. The channel mounts to the wood framed wall should be explored for hidden damage, as decay is likely.

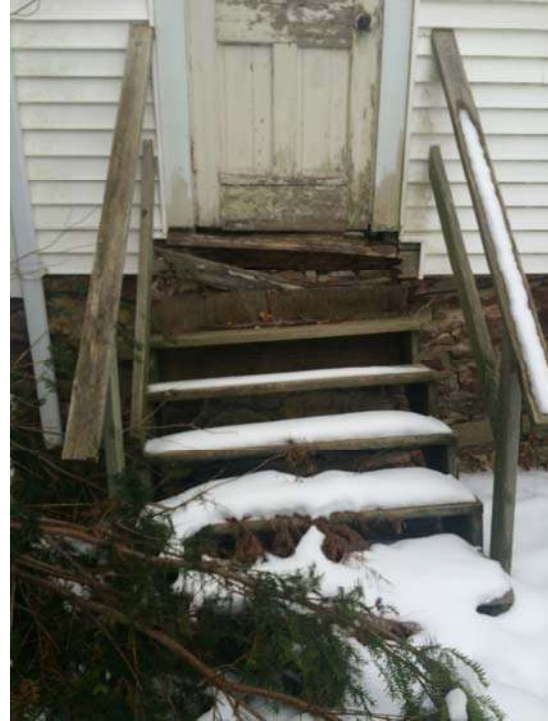
There are two wooden stairs: one on the north face and one on the west face. Both stairs are a set of two notched stringers with plank treads, attached to the building with a ledge-style connection. The stair on the north face is eight risers tall, when counting the bottom stone step and the step into the building, while the stair on the east face is only five risers in height. Both of the stairs are in an advanced state of deterioration leading to structural failure. In each case, there is a focused deterioration of the wood ledger connection to the exterior walls of the additions, leading to detachment of the stair and partial structural collapse. The north stair is now only partially

attached to the building, while the west stair, seen in Figure 7, has completely detached (with the exception of the hand rails). Although much of the connection from the stairs to the wood framed wall is concealed by finishes, there was visible evidence of decay, indicating that the connection at these locations may have failed due, at least in part, to decay at the ledger. The walls should be inspected for concealed damage at these locations.

Figure 7: West Stair - Failed Connection

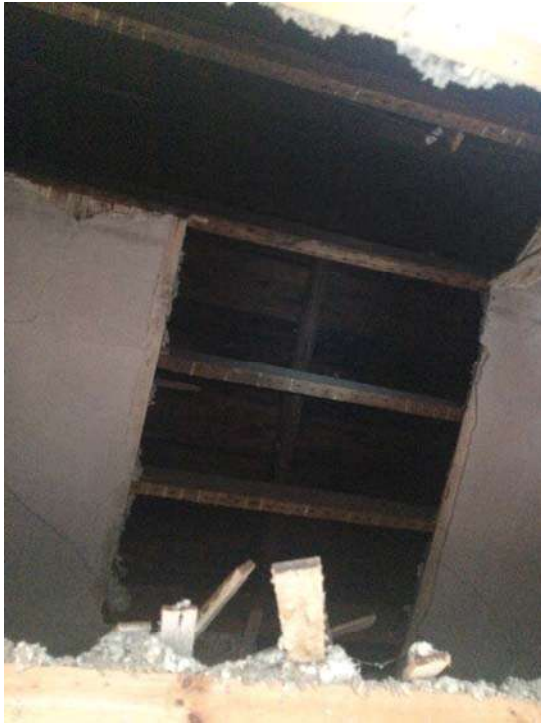
The roof framing of the additions were not available for review in all areas. The framing of the area with the north-south ridge line was available for review in Unit #5 through an area of collapsed finishes and an area of cut finishes. This area of the north-south ridged roof is framed with dimensional rafter framing, though the area was improperly framed as a cathedral without

accounting for the outward thrust of the rafter (seen in Figure 8). This area has experienced multiple inches of sag in the ridge, lateral deflection of the tops of the stud walls, and tearing of the ceiling finishes (Figure 9). The framing of the area with the east-west ridge line was available for review in Unit #5 through a permanent access port. This area of the east-west ridged roof is framed with standard dimensional rafter and tie framing. There were no overt signs of failure within the east-west ridge line, though the finishes may be concealing unknown adverse conditions.

Figure 8: Roof - Unit 5 - Roof & Improper Cathedral

The roof of the north-south ridge of the addition has undergone downward deflection, and the perimeter walls have been splayed outward, tearing the ceiling loose from the studs. This damage is being caused by the un-restrained outward thrust of the rafters of the gable roof. In standard construction, this force is restrained by the ceiling joists acting as rafter ties. The non-structural ridge of the roof should be jacked back into its original position with a series of jack columns. These jack columns should be supported with in-line columns from the crawlspace floor to the ridge-line. Come-alongs and struts may be used as required to assure lateral position of the ridge during this jacking. Once the ridge is in place, with the bow corrected, the rafters ends should be tied wall to wall. This can be achieved by re-framing the roof to allow the joists to act as ties, but,

as a cost saving option, our office advises installing cable ties above the existing ceiling joists in this case. Care should be taken to avoid creating a tripping hazard with the cables.

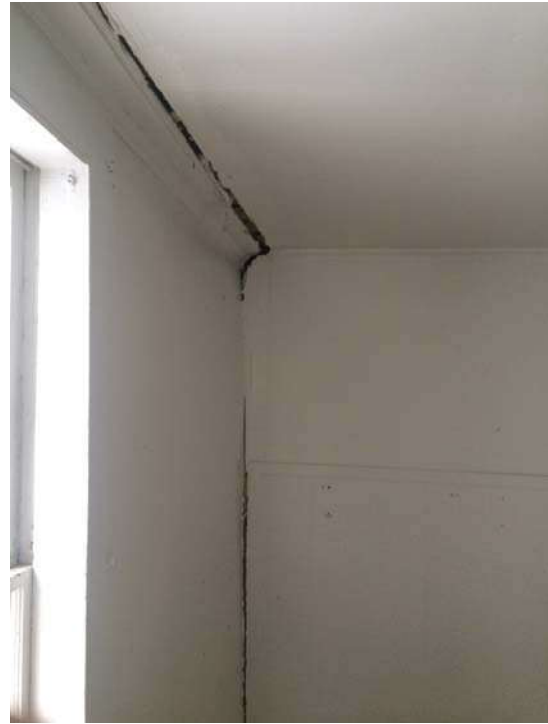
Figure 9: Roof to Wall - Unit 5 - Rafter Lateral Failure

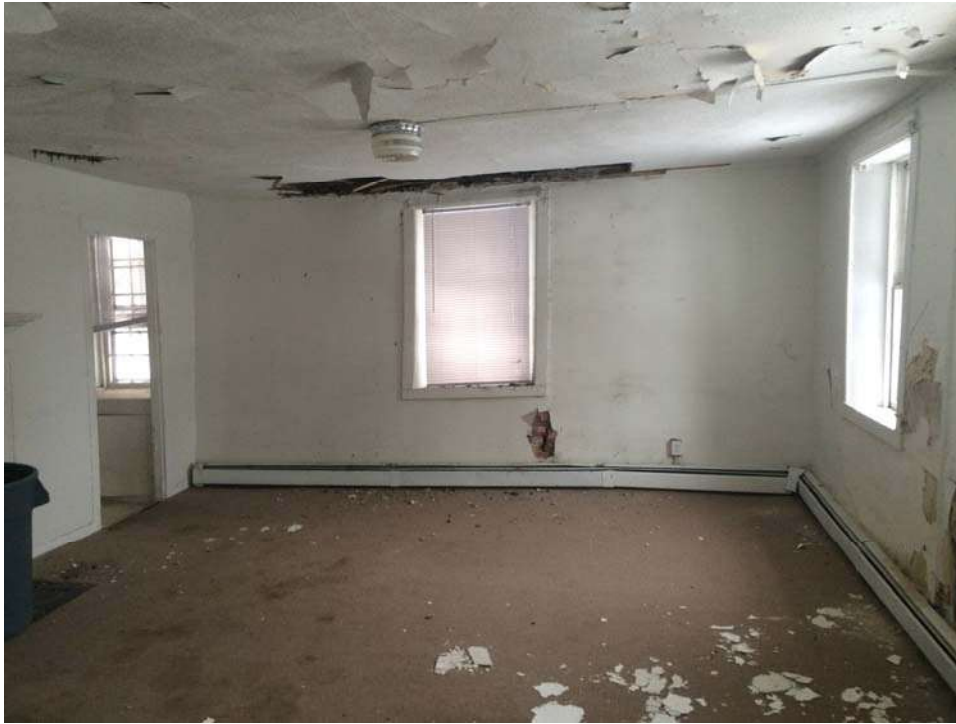
The second (2nd) floor framing of the original structure is almost entirely finished, and obscured from visual review. The framing could be observed in an area of collapsed ceiling finishes adjacent to the east wall of the main building (Figure 12 & Figure 13). In this location, the observable floor framing was comprised of wooden floor joists (approximately 2"x8") running north to south, presumably bearing on the interior partition walls of the first story. Based on the framing observed below, and the layout of the walls and chimneys in the building, it is presumed that the framing on the observed east half of the floor bears on the walls running along either side of the chimneys where the load is carried by underlying masonry and timber supports. It is possible that the framing varies on the west half of the floor. Capacity is likely near 40psf, with higher than code prescribed deflection, if assumptions about the concealed framing are accurate, and the framing is undamaged.

Figure 12: Visible 2nd Fl. Framing, Looking East on 1st Fl.

The second (2nd) floor framing of the original structure will likely require substantial framing repair

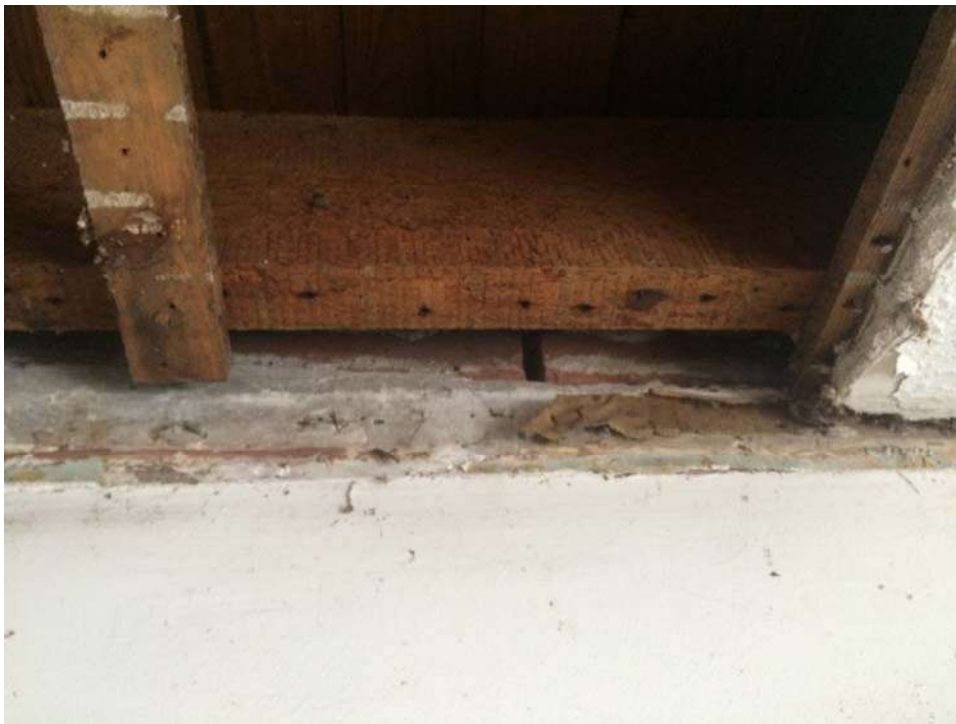
Figure 13: Visible 2nd Fl. Framing, Looking East on 1st Fl.

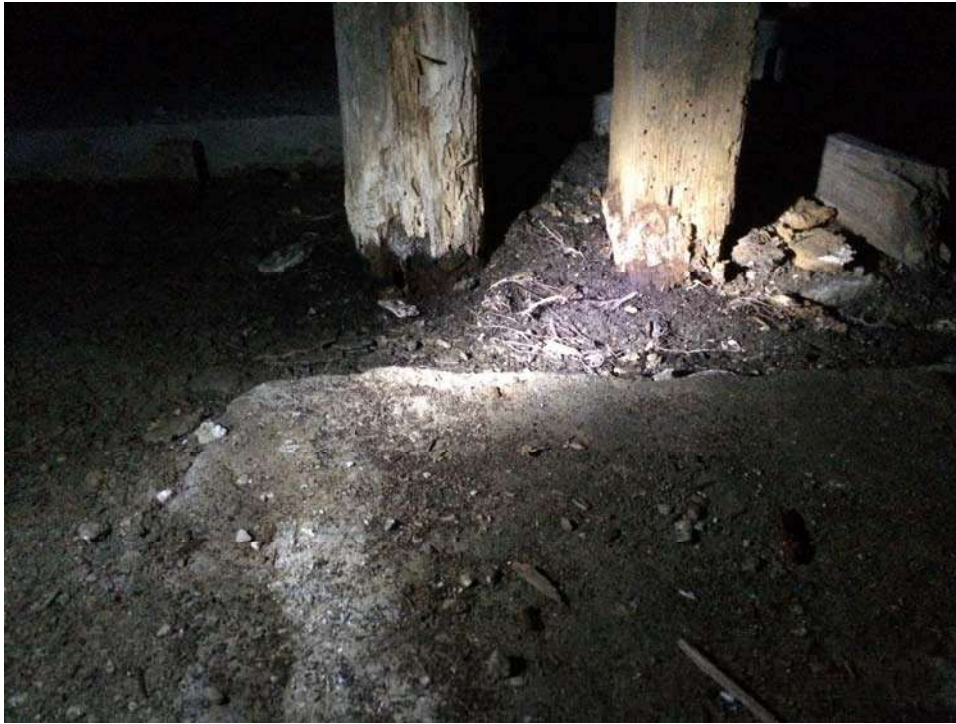
Figure 14: Basement - Decayed Column Bases, Typical Condition

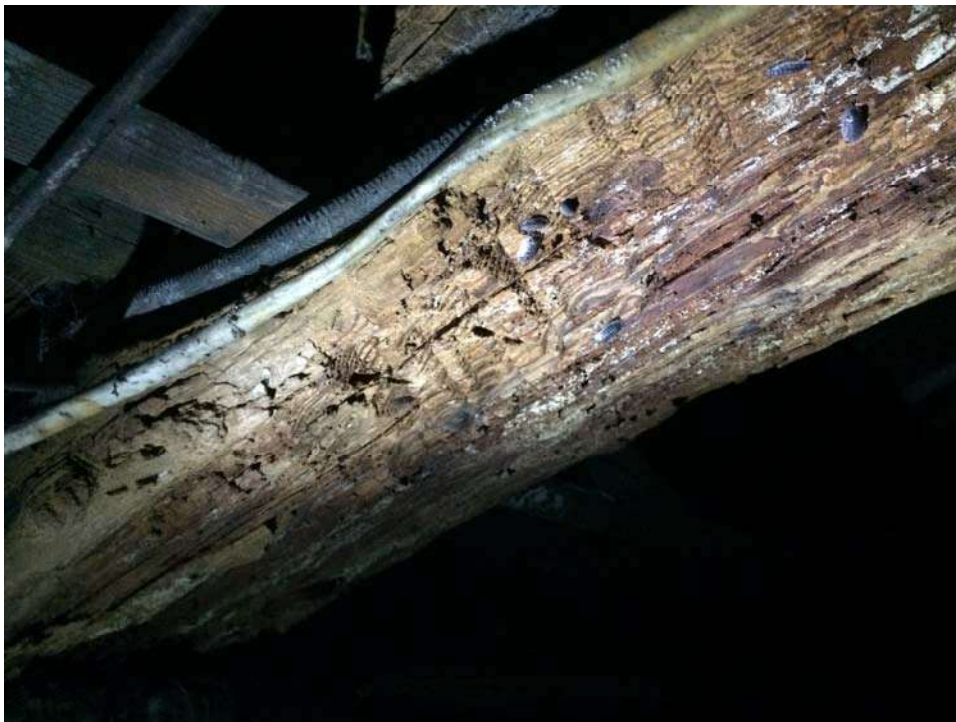
Figure 15: Basement - ±15' Northeast of Southwest Building Corner - Severely Deteriorated Beam

There is a full unfinished basement below the original building. The exterior foundation walls of the basement are stone masonry foundation. There is a mixture of brickwork and concrete work in areas of the original stone masonry foundation; this seems to be new work installed to correct various defects. One noteworthy area of repair is a poured concrete patch/reinforcement of the foundation along the east wall below the area of deformation in the exterior brickwork. The brick is hard fired, with no evidence of soft brick. The basement is mostly exposed earth, though there are some areas which have been rendered more sanitary through the application of a screed of concrete on grade. Most of the interior posts supporting the first floor framing are bearing either directly on earth or on single flag stones/cobbles lain on the earthen floor. Due to this improper support most of the columns exhibit signs of extensive decay and/or damage from pests such as mites/insects (Figure 14). The air in the basement is humid, which has allowed extensive growth of fungus and molds, damaging the wood framing (Figure 16, 17 & 18). Our office estimates that more than 20% of the timber framing in the basement, including the first floor framing exposed in the basement, is damaged beyond acceptable continued use without replacement/repair.

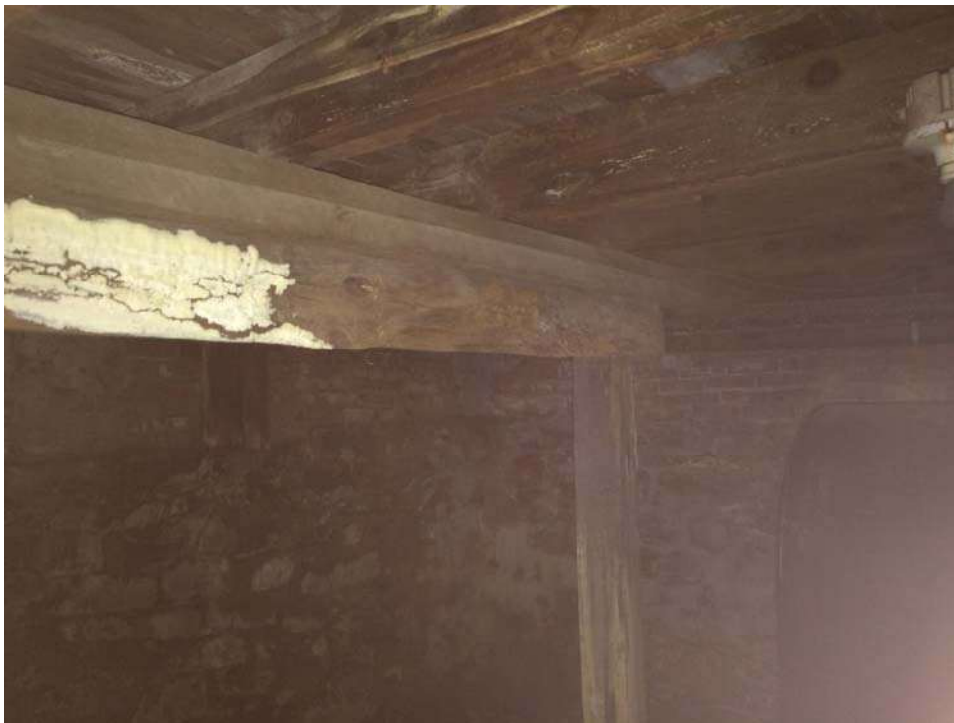
Figure 16: Basement – Looking Southwest Toward Southwest Corner - Mold Growth

There has also been water/moisture infiltration in the basement and, to a lesser extent, the crawlspaces, resulting in water damage to finishes and mold growth on the exposed framing. The damage is most severe at the bottom of the posts, though there is substantial damage noted in the wood framing of the 1st floor above. The basement is currently poorly conditioned, which creates an environment conducive to mold growth. Per building code, any materials used in a poorly conditioned or “unconditioned” space should be pressure treated, or otherwise resistant to mold/termite/fungal attack. This restriction applies to wood in contact with masonry exposed to inclement conditions, such as ground contact or exterior exposure. As such, sill plates and seated joists in the basement should be pressure treated and/or exposed to conditioned air. The air in the basement must be more thoroughly conditioned (dehumidified/circulated) or the first floor framing will be damaged by exposure to the poor conditions/moisture. It is possible that this moisture issue is new, and is an artifact created by the fact that the building is currently uninhabited. The power had been off at the time of our site visit on December 28th, 2017, and there was no indication that it had recently been on.

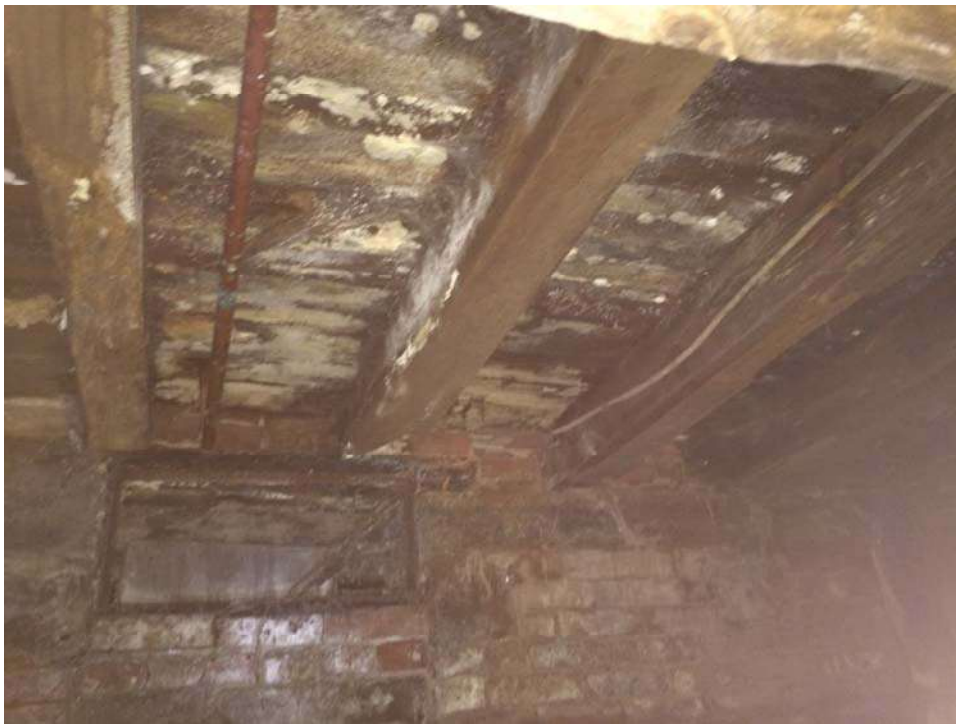
Figure 18: Basement – Looking South Toward South Wall - Mold Growth

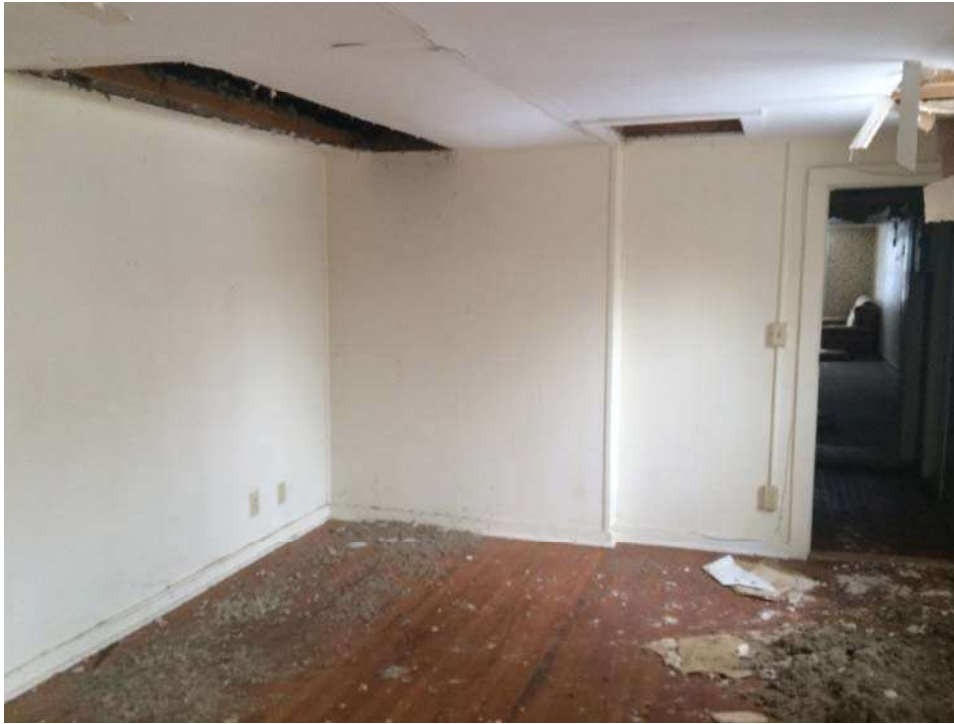
There is water damage in the addition area to the north of the entry to Unit #5 on the 2nd floor. The damage is mostly limited to the roof and 2nd floor platform, and was unable to be viewed without removing the ceiling finish in the 1st floor. The roof and 2nd story ceiling have locally collapsed due to the water damage and have been roughly patched. The 1st story ceiling is damaged and should be removed and replaced in the area. When replacing the ceiling, the joists/rafters should be inspected for any damage/decay which may not be apparent before the removal of the finishes. It should be noted that daylight could still be seen near this area from the north eave crawlspace of the 3rd floor of the original building.

Figure 19: Unit 5 Looking South, Water Damaged Ceiling

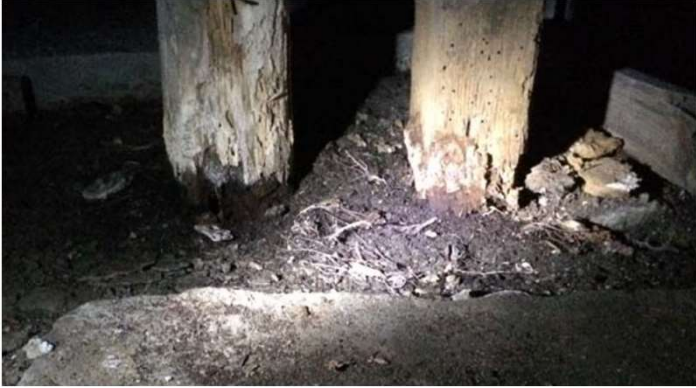
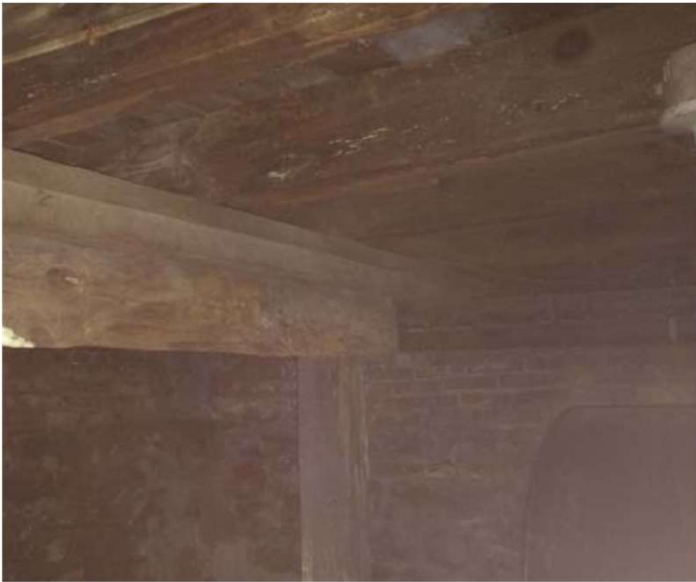
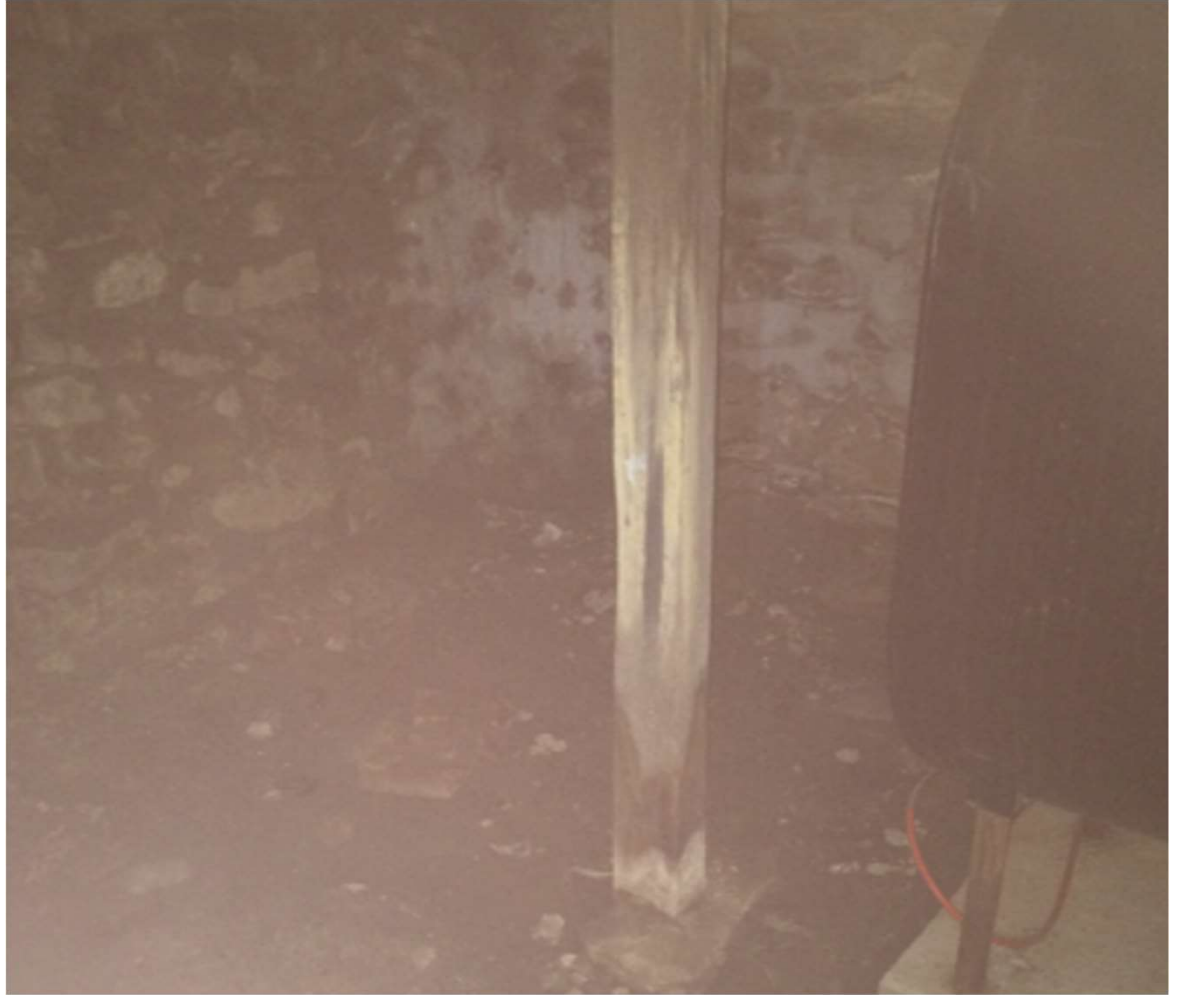
- GG10** Basement support beams - some in good repair, others, not. This would be one of the first repairs we make.
Photo on right shows end of 1 of 2 oil tanks.
Gwen George-Bruno, 1/4/2021
