REQUEST FOR PROPOSALS: VOLUNTOWN METHODIST MEETING HOUSE

RFP#: VOL2023/2023-2
Title: Voluntown Methodist Meeting House
Issue Date: July 1, 2022

Reference: Voluntown Methodist Church - Cursory Structural Conditions Assessment, 2017 Update

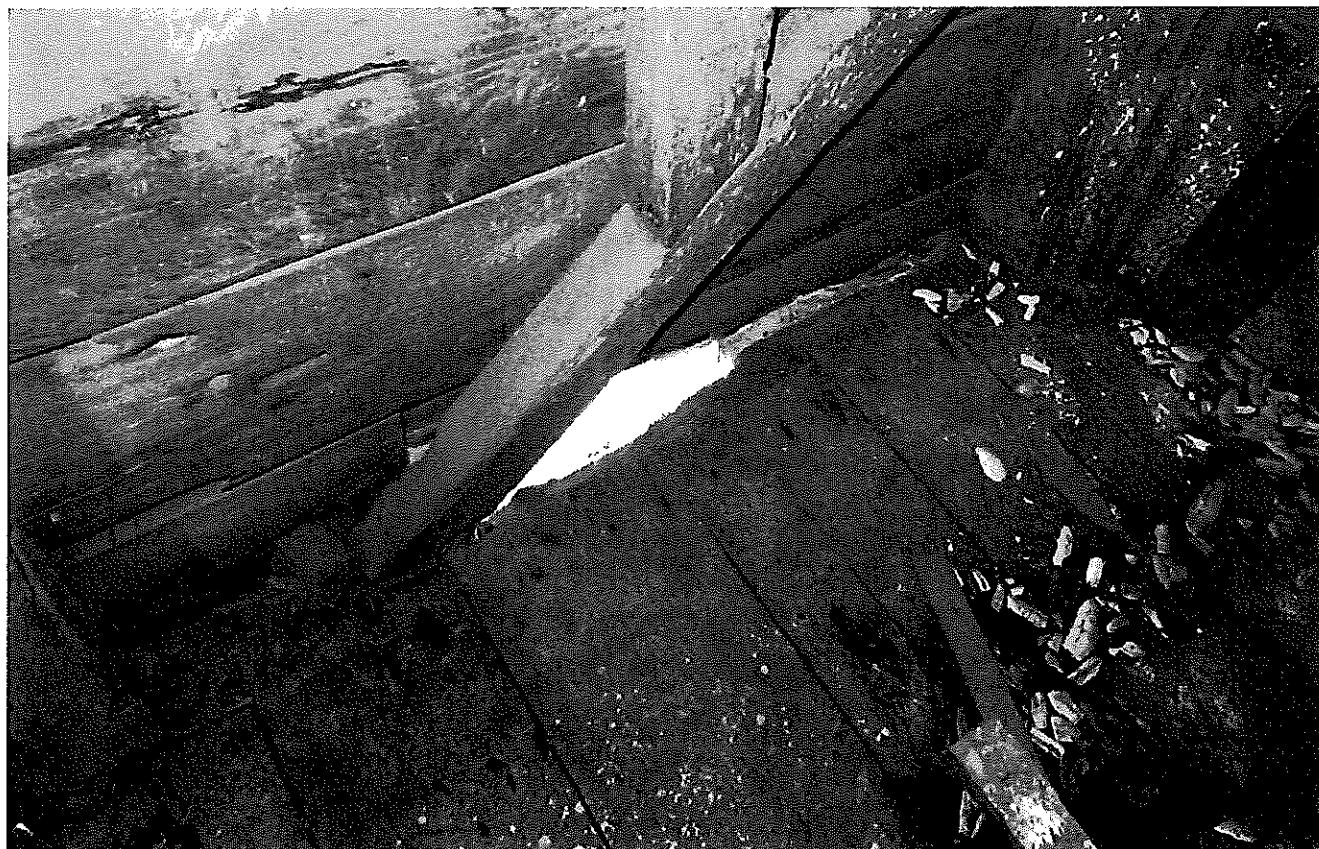
- S-1** Deteriorated sills. 2017 Update: We observed additional sill deterioration and termite damage on both walls adjacent to the north-east corner. 2013: The sill appears to be in a varying state of deterioration along the perimeter of the building. In addition to the area noted in item S-2 below, an outward rotation of the top of several of the granite foundation stones is indicative of deterioration of the outer half of the bottom face of the sill causing rotation of the wall above and foundation below. Deterioration often affects the bottoms of the posts and studs attached to the sill. *All deteriorated sills should be replaced with rot-resistant white oak timbers. In order to better define the scope of sill, post and stud damage, the sill should be further studied and consideration given to exposing it for investigation in certain locations. See below for discussion of immediate make-safe repair recommendations.*

S-1 Deteriorated sill, north-east corner (2017)

2017 Update: In 2014, shoring was installed to support the north elevation and cables installed at the eaves of the trusses. Shoring was not constructed in the south-east corner. 2013: We recommend that temporary support be added as soon as possible to ensure the stability of the building in the upcoming winter / snowy months. Cables should be constructed to connect the east and west eave beams beneath each of the interior trusses; these should be made snug-tight with a turnbuckle but not tensioned. Temporary support should be added

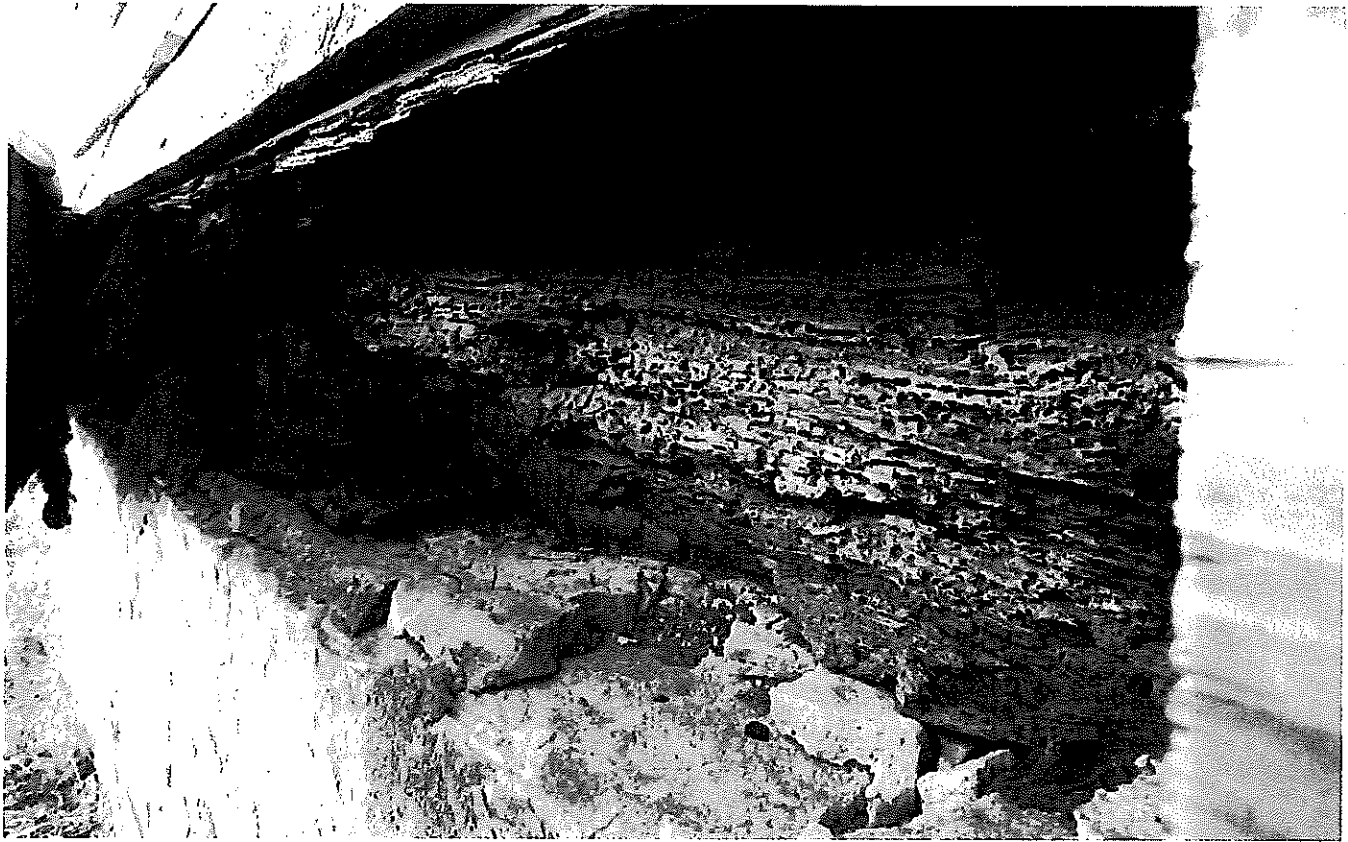
S-1 Deteriorated sill, east side (2017)

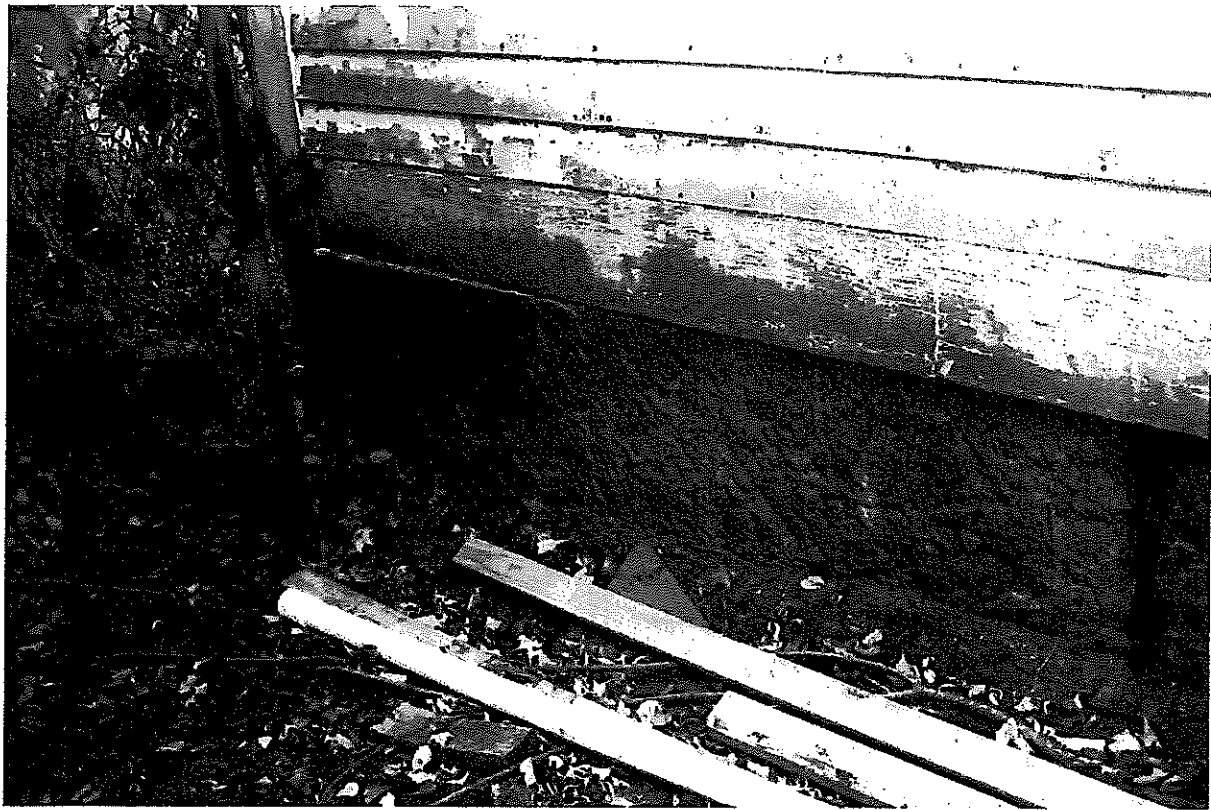
S-1 Shifting at foundation below sill, north-west corner (2013)

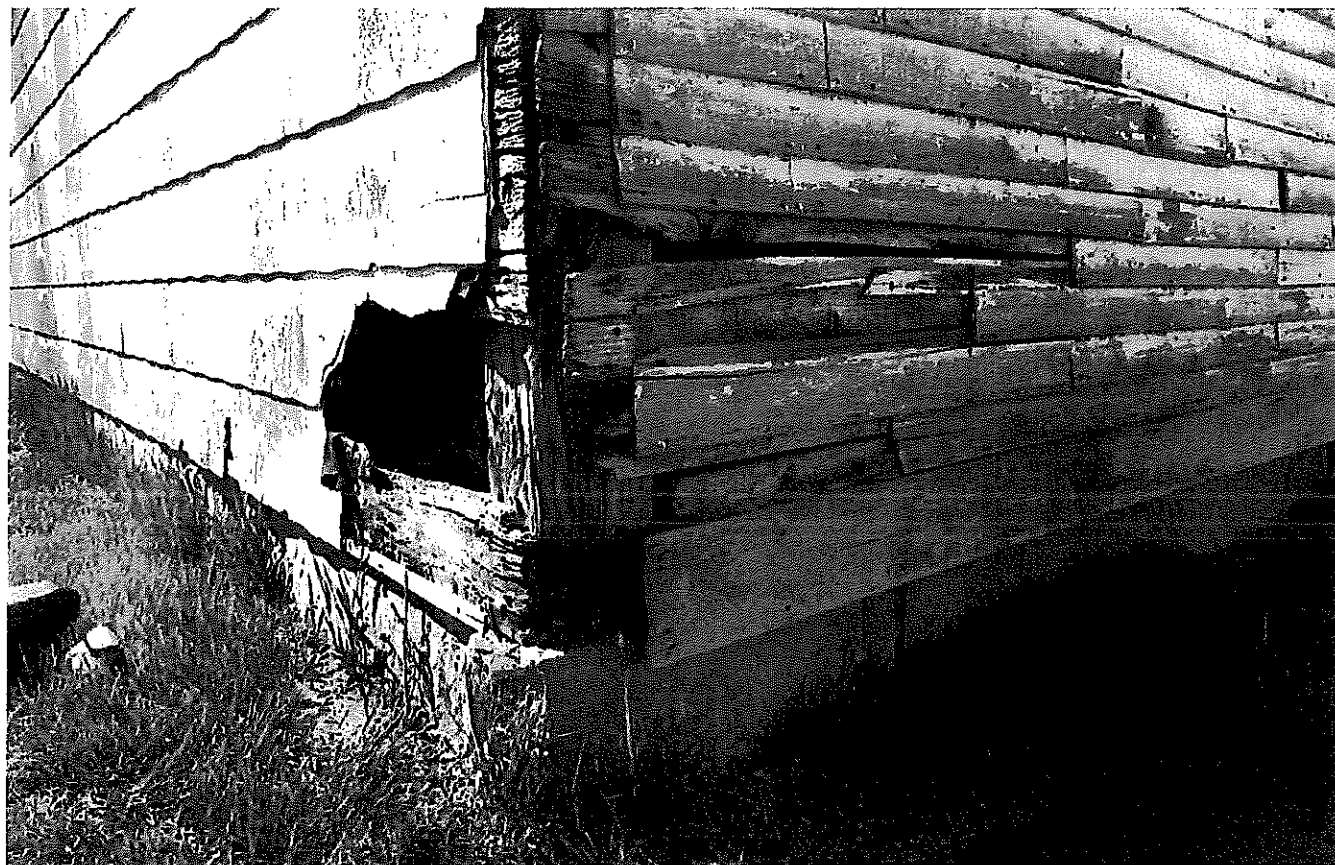
- S-2** South-east corner deterioration. 2017 Update: Shoring was not performed in this area and still remains compromised. 2013: Severe deterioration is evident in the south-east corner due to a breach in both the siding and cornice / roof in this area. There is very little integrity left in the sill or post-base, and eave beam and connecting rafters also appear to be compromised. The roof load in this corner has been shed to the adjacent studs; *however the sill, post, braces and possibly eave beam and rafter tails in this area must be replaced to restore full integrity. See below for discussion of immediate make-safe repair recommendations.*

S-2 Deterioration at south-east corner (2017)

to the south-east corner and at the failed members below the former tower on the north elevation, particularly the currently unsupported roof purlins.

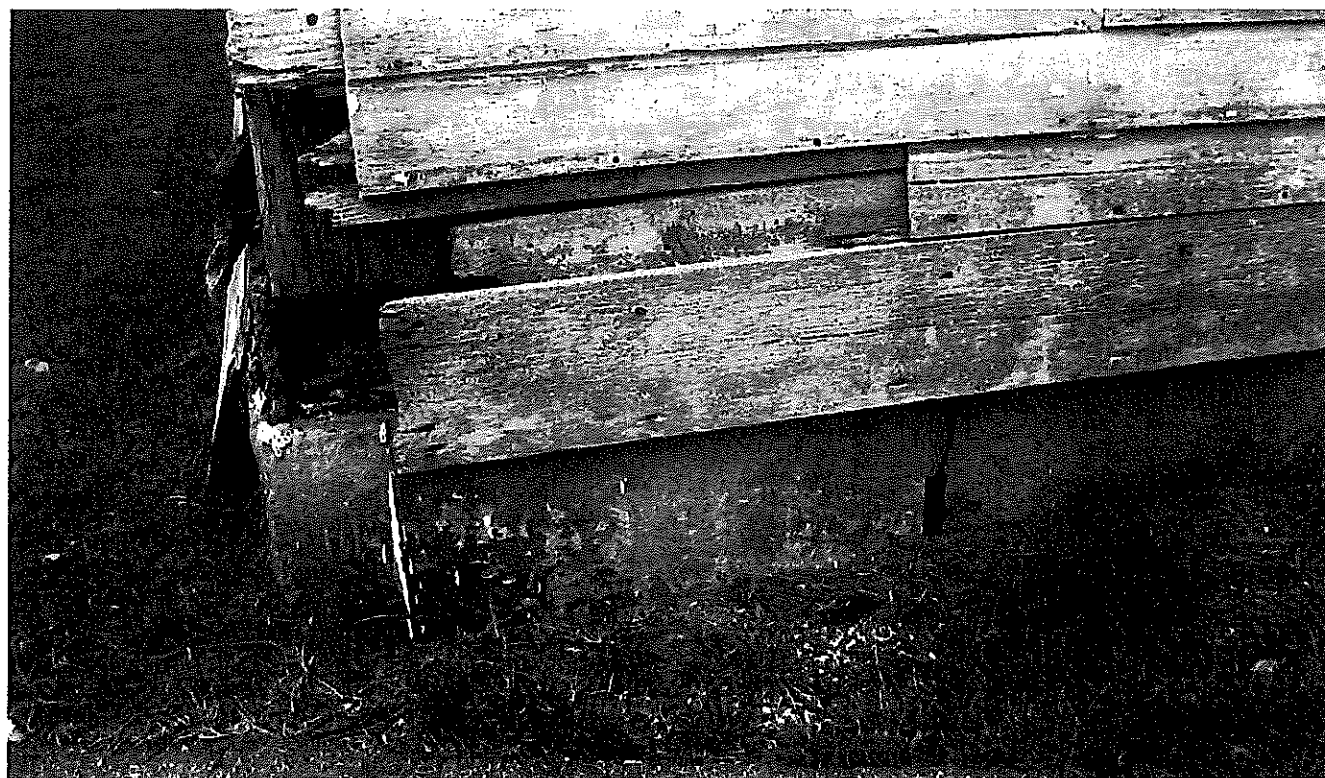
S-2 Deterioration at south-east corner (2013)

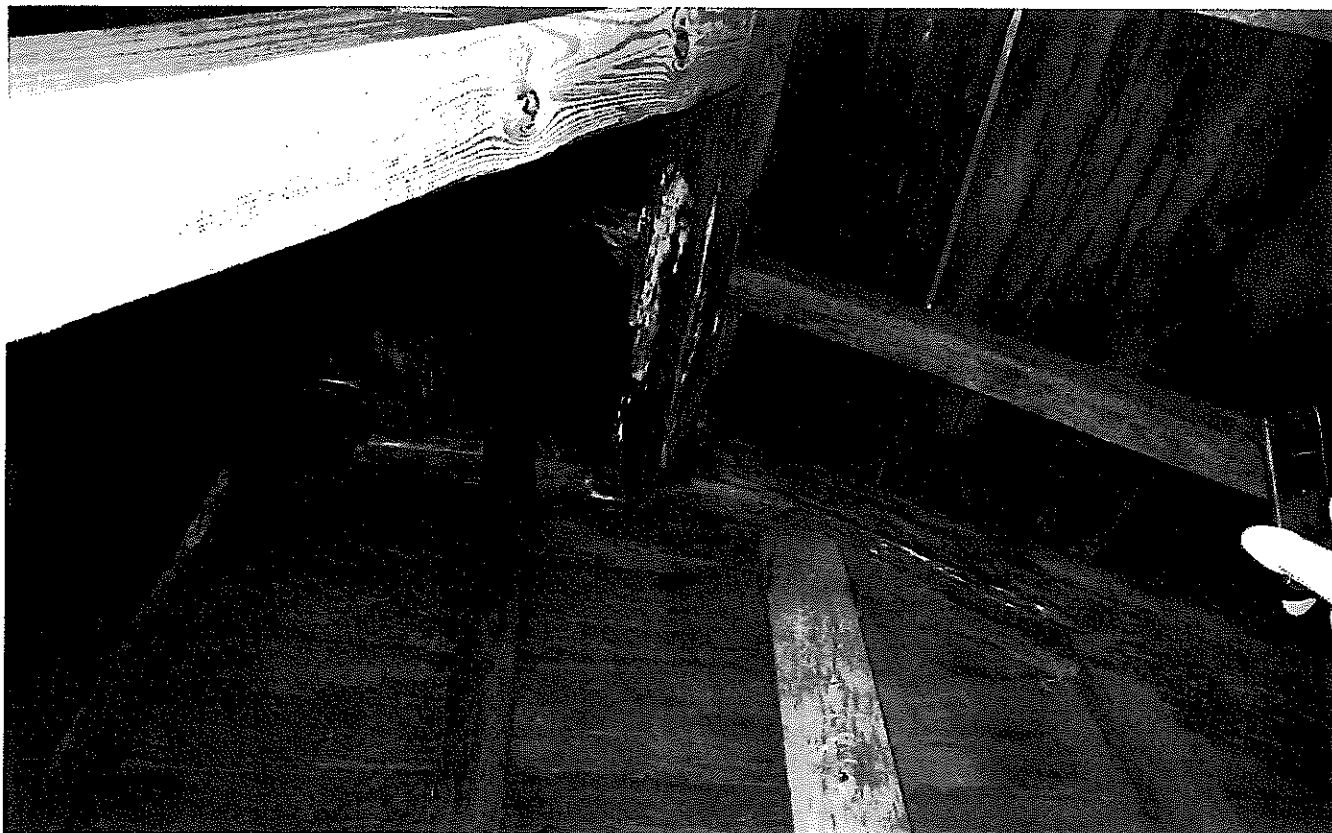
- S-3** Deterioration below tower. 2017 Update: Shoring was installed in early 2014. Deterioration of the framing has continued due to roof and siding breaches

creating additional areas of limited ability to support the end bay of the roof and north wall. Without structural intervention, there is no guarantee that this area can support snow, hurricane or seismic loads, and with continued deterioration this area may lose its ability to support its own dead loads.

2013: The roof and wall framing on the north elevation that once supported the tower has seen severe deterioration due to breaches in the roofing and siding. The raking end rafters have severed where the mid-slope purlin frames in on both east and west sides. The west side remains unsupported and the east side is shored with a temporary, but undersized, stud. The wind girt running at eave level is also severely compromised. *We recommend that all compromised members be replaced. Should a comprehensive restoration plan include resetting the tower, the former tower posts should all be assessed for condition and integrity. See below for discussion of immediate make-safe repair recommendations.*

S-3 Deteriorated rafter and purlin connection on east slope of north wall with shoring (2017)

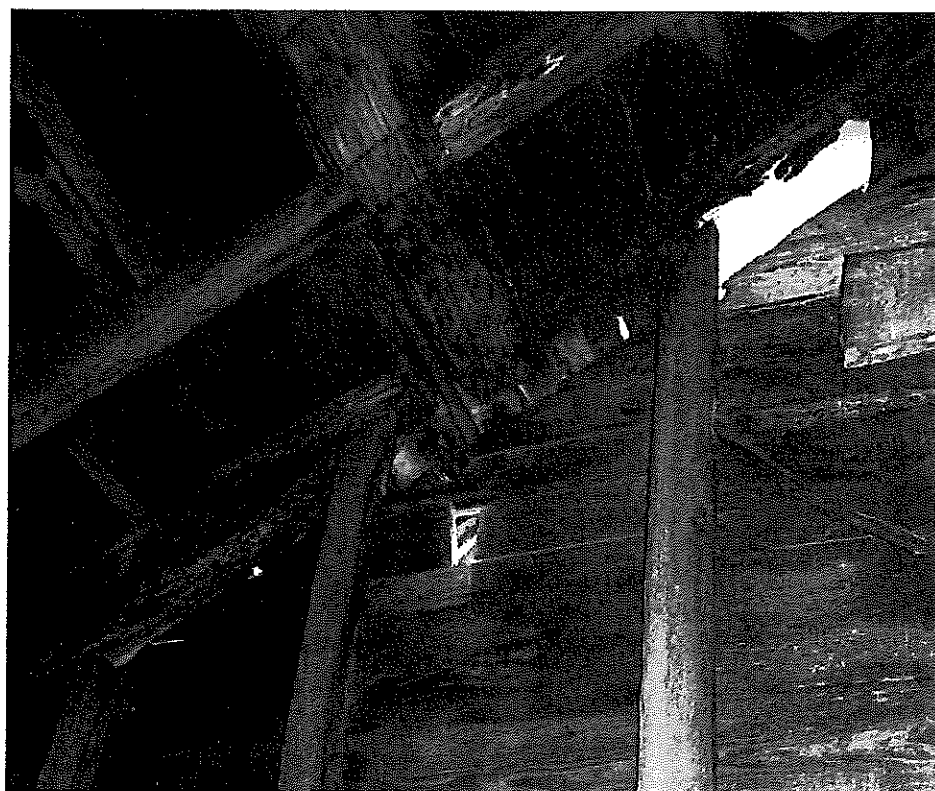
S-3 Deteriorated rafter and purlin connection on west slope of north wall (2013)

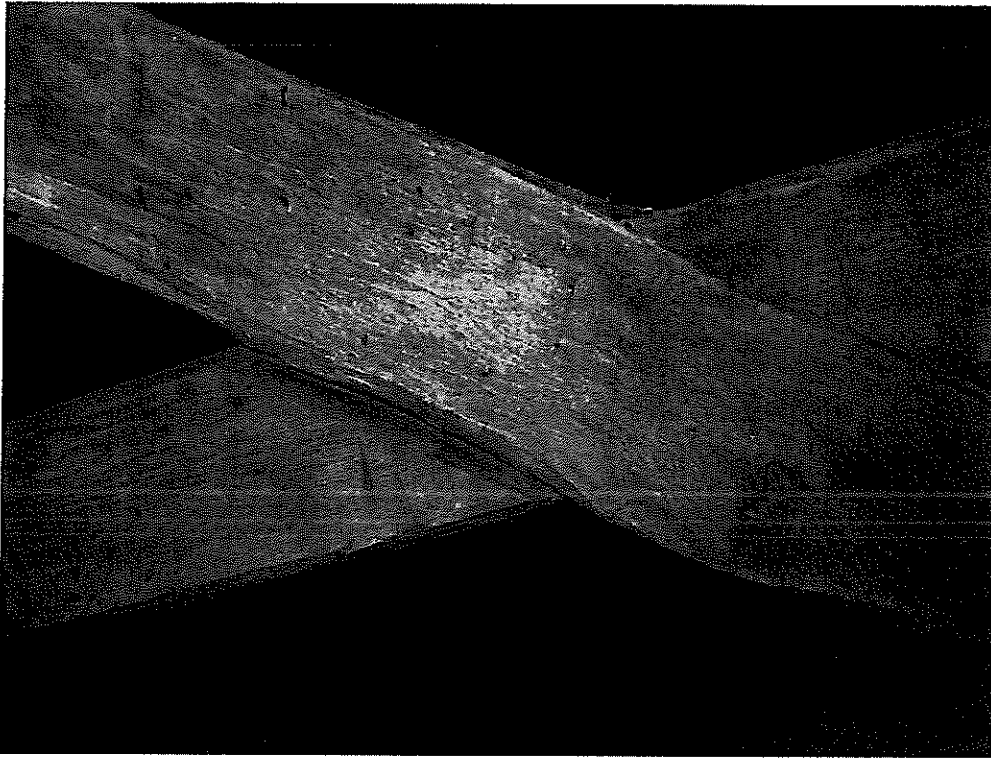
S-4 Scissor truss separation. 2017 Update: Eave to eave cables were installed in early 2014. We were not able to evaluate whether lateral thrust loads are currently being supported by existing truss joinery at the eaves, or if joinery failures have occurred causing thrust loads to be transferred to cables. 2013: By nature scissor trusses have a tendency to spread due to the indirect orientation of the eave restraint, as opposed to direct eave to eave restraint typical of other truss types. In this case, I observed some minor separation at the scissor cross as well as some bowing at the eave on the east wall. I was not able to assess the integrity of the eave joint. *The truss should be more closely studied during a comprehensive restoration program to determine whether the joints require reinforcement. See below for discussion of immediate make-safe repair recommendations.*

S-4 Joint opening at east eave end of scissor-cross (2013)

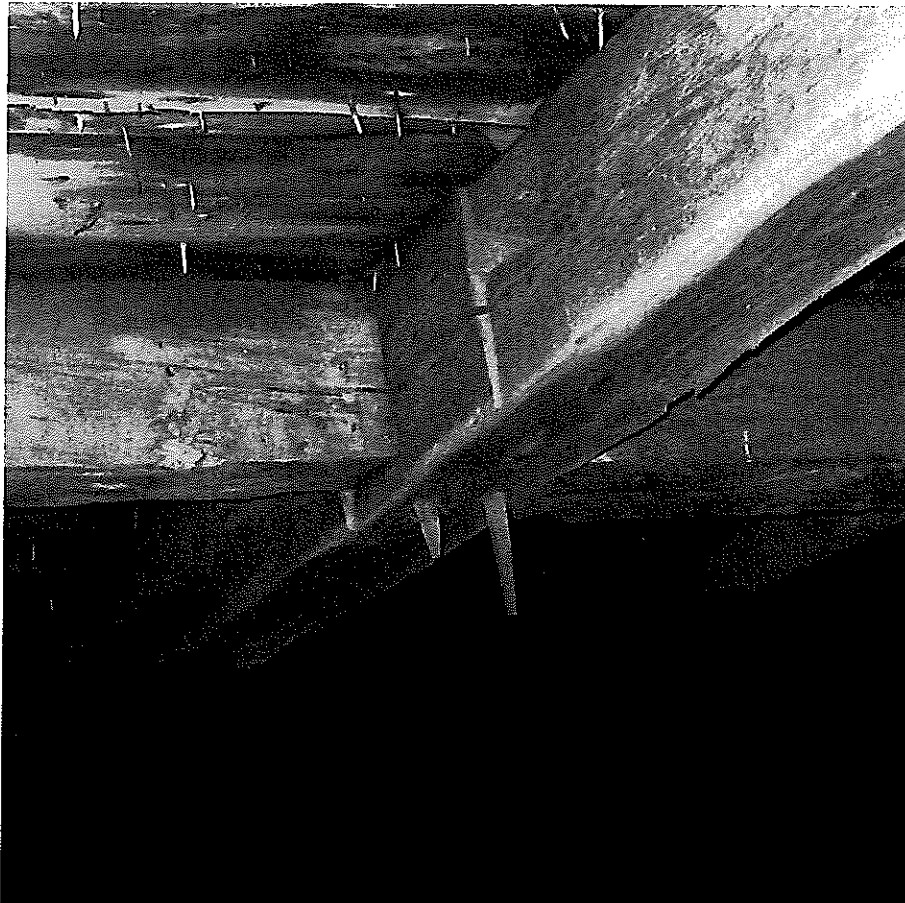
S-5 Purlin Connection Splitting. 2017 Update: We did not observe any change in this condition. 2013: Horizontal splits are evident in the purlin at the connection to the trusses. The splits are evidence of a shear stress concentration where the purlin end is reduced into the mortise. *There are a number of joint reinforcement details that could be employed to address this problem during a comprehensive restoration project.*

S-5 Horizontal shear split in purlin end (2013)
