A Survey of Historical and Architectural Resources

HISTORIC RESOURCES INVENTORY FORM

- 1 BUILDING NAME Common Southmayd Homestead Historic. Partridge Southmayd House; Southmayd Homestead
- 2 TOWN/CITY Middletown VILLAGE Staddle Hill COUNTY Middlesex
- 3 STREET & NUMBER (and/or location) 797 Washington Street
4. OWNER(S) Harriet B. Redford PUBLIC ☐ PRIVATE ☒
- 5 USE Present Residence Historic same
- 6 ACCESSIBILITY TO PUBLIC Exterior visible from public road ☒ yes ☐ no
Interior accessible: ☒ yes, explain with occupant's permission ☐ no

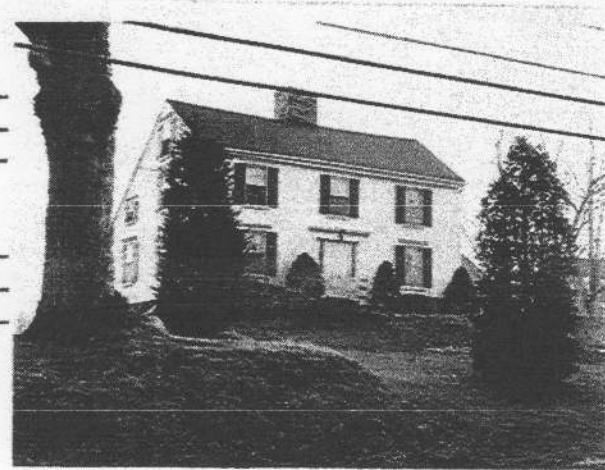
PHOTOGRAPH

- 11 NUMBER OF STORIES 2 1/2 APPROXIMATE DIMENSIONS. 25'x40'
12. CONDITION Structural ☐ excellent ☐ good ☒ fair ☐ deteriorated
Exterior ☐ excellent ☒ good ☐ fair ☐ deteriorated

- 13 INTEGRITY Location ☒ on original site ☐ moved, when
Alterations. ☐ no ☒ yes, explain Alterations to plan; flooring, doors on interior
14. RELATED OUTBUILDINGS OR LANDSCAPE FEATURES

This saltbox house with three-bay facade lacks the characteristic overhang of mid-eighteenth-century domestic construction. Although the appearance of the house has been altered through enlargement of the windows and other cosmetic changes, it retains much of its original fabric, including fireplaces and a fine triple-run staircase.

date 12/78 view northeast
