**RFP – Request for Proposal
for a Feasibility Study on Adaptive Re-Use**

**Requested by
Windham Preservation Inc.
Nine Weir Court
Windham, CT 06280**

Structural Condition Assessment Report
Windham Inn
4 Scotland Road
Windham, CT 06280

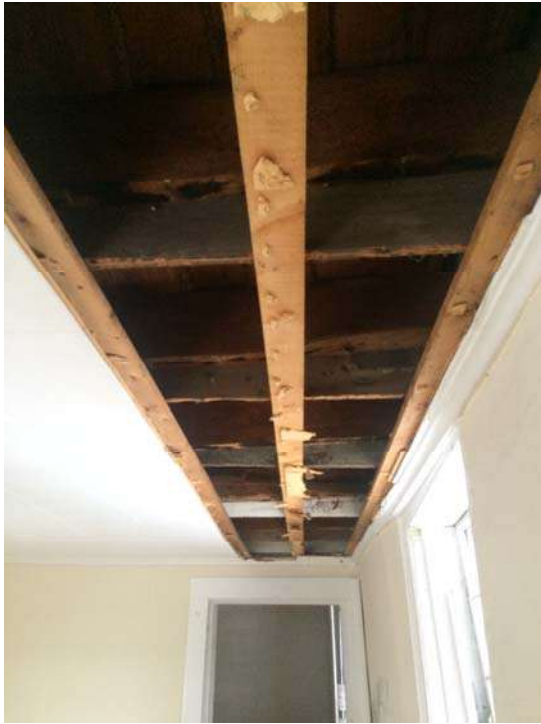
The third (3rd) floor framing of the original structure is almost entirely finished, and obscured from visual review. The framing could be observed in an area of collapsed ceiling finishes adjacent to the east wall of the main building (Figure 10 & Figure 11). In this location, the observable floor framing was comprised of wooden floor joists (approximately 2"x8") running east to west, bearing in lumber in-set within the masonry of the east wall. Based on the framing observed below, and the layout of the walls and chimneys in the building, it is presumed that the framing bears on the walls partitioning the central stair/hallway and possibly on the chimneys where intersecting the masonry. The bearing condition at the east wall must be presumed structurally unsound unless it is either independently supported, or the masonry wall is adequately stabilized. Capacity is likely near 40psf, with higher than code prescribed deflection, if assumptions about the concealed framing are accurate, and the framing is undamaged.

The floor is out of plumb/level, by several inches, in such a way as indicates settlement of the interior of the original building. This conjecture is in agreement with all other relevant observations.

Figure 10: 3rd Fl. Framing, Looking North on 2nd Fl.

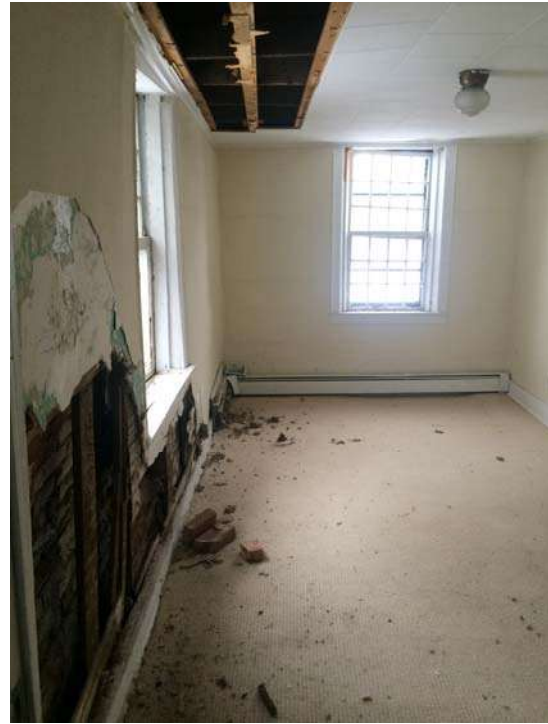
Figure 11: 3rd Fl. Framing, Looking South on 2nd Fl.

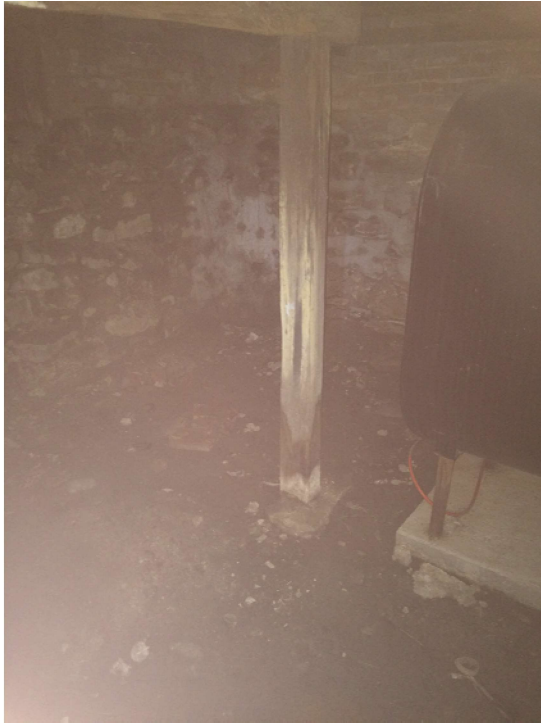
There is a crawl space below the additions. The crawlspace is comprised of a combination of CMU foundation along the eastward wing of the addition, and dry-laid stone masonry foundation in the less accessible northward addition. The wood posts in the crawlspace are bearing either directly on earth or on single flag stones/cobbles lain on the earthen floor. Several of these columns have fallen from their original position and had to be re-set/shimmed. Due to this improper support most of the columns exhibit signs of extensive decay and/or damage from pests (mites/insects). Although there is less evidence of mold/fungus growth in the addition than in the original structure, the moisture is still in excess of the recommended RH values lower than 60%, and will lead to rapid decay if left un-checked.

Figure 17: Basement – Looking Southwest Toward Southwest Corner - Mold Growth
