HISTORIC RESOURCES INVENTORY—BUILDINGS AND STRUCTURES
Please send completed form to: State Historic Preservation Office, Department of Economic and Community Development, One Constitution Plaza, 2 nd Floor, Hartford, CT 06103 *Note: Please attach any additional or expanded information on a separate sheet.
GENERAL INFORMATION
Building Name (Common)
Building Name (Historic) Culbro Tobacco Division Farm #4
Street Address or Location 1503 Hopmeadow Street
Town/City: Simsbury Village Hoskins Station County: Hartford
Owner(s) River Bend Associates, Inc.
PROPERTY INFORMATION
Present Use Vacant
Historic Use Tobacco barn
Accessibility to Public: Exterior visible from public road? Xes
Interior accessible? Yes No If yes, explain
Style of building Vernacular Date of Construction c. 1920s
Materials (Indicate use or location when appropriate):
Clapboard Asbestos Siding Brick Wood Shingle Asphalt Siding
Fieldstone Board & Batten Stucco Cobblestone Aluminum Siding Concrete (Type) Cut Stone (Type) Other: Horizontal barn board

A group of five tobacco sheds, lined up end to end, south to north, on the west side of Route 10. The buildings are on a slight rise, hard on the road, to the northeast of th

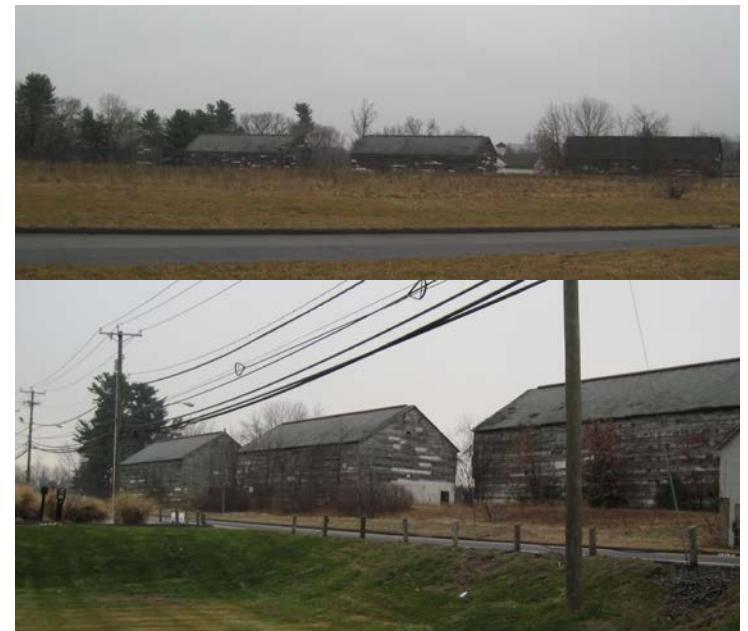
View: From the northeast and southwest Negative on file

These five barns have a similar design: an elongated peak-roofed building with its gable ends to the north and south; wagon entries in the gables. The venting system is the horizontal-board type operated with vertical hinges. Narrow vents cap the roof ridges, running almost the full length of the building but stopping just short of the gables. The north is nearly double the length of its four neighbors. Traces of exterior whitewash.
